AN INDEPENDENT REFINER'S APPROACH— PRACTICAL SOLUTIONS TO COMPLEX GEAR PROBLEMS

John B. Cary

Reliability Superintendent—Avon Refinery
Tosco Refining Company
Martinez, California

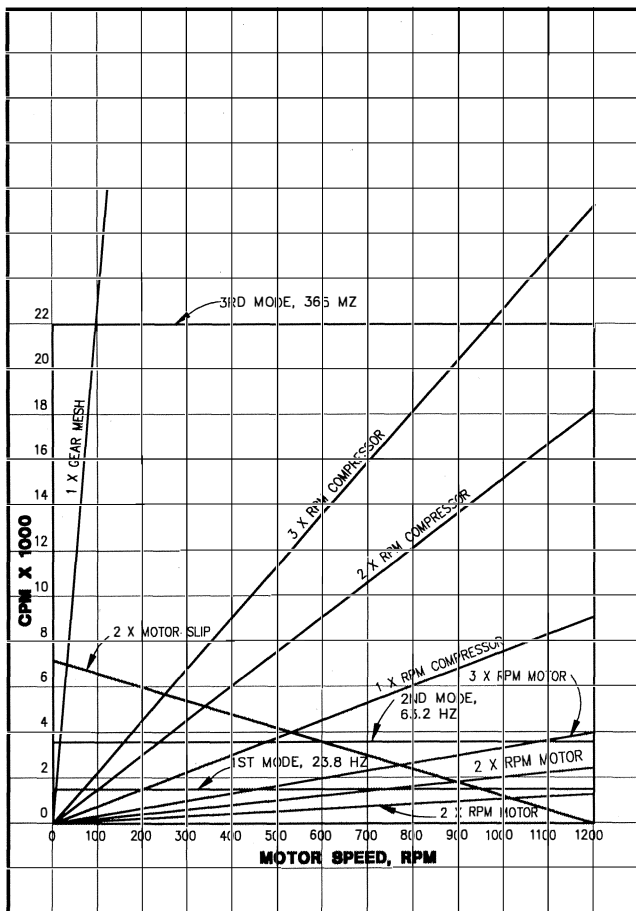
Over the years, a total of four torsional studies were performed on the system. The first was calculated by the compressor supplier, who also supplied the gear and motor. His calculations revealed no harmful torsional frequencies in or near the operating speeds. The rotor torsional critical speed map shown in Figure 5 was supplied with the analysis results.

Figure 5. Rotor Torsional Critical Speed Map Including Motor, Gear and Compressor.

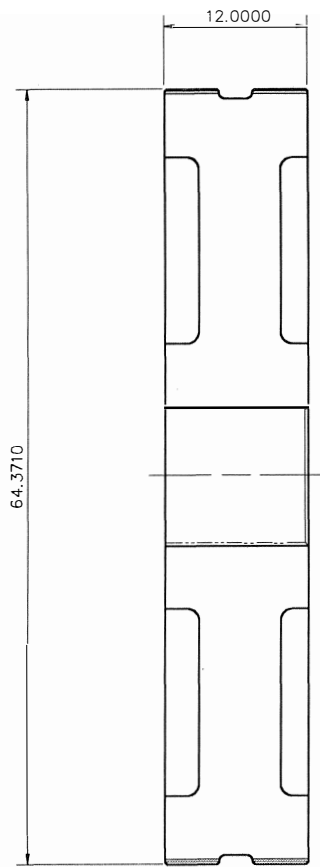
Based on the preliminary analysis performed, the decision was made to use the partially hogged gear design (Figure 11). It had the greatest separation from the torsional critical while exhibiting good bearing stability at 100 percent load (Table 2).

Figure 11. Partially Hogged Gear Profile.

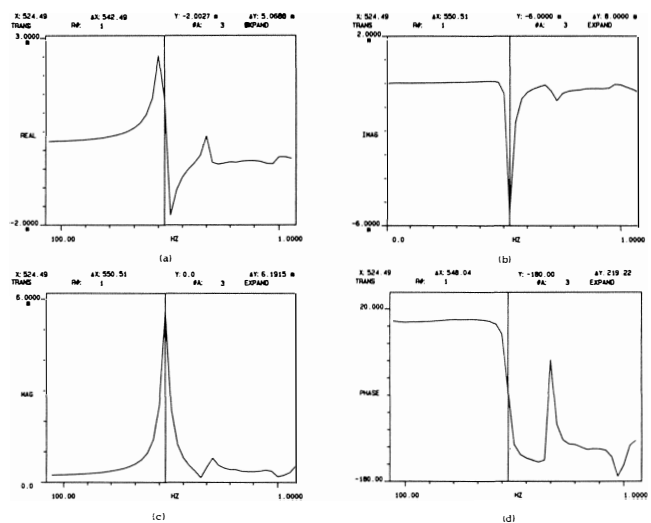
Common gear structural characteristics and observed pinion behavior strongly suggest a highly complex interaction between the two gears. Specifically, this involves excitation of a pinion critical at approximately three times operating speed which may be coupled to a nearby cymbal mode resonance in the gear.

Excessive pinion axial motion and gear “wobble” has been observed and calculations allow the possibility that the wear pattern may be closely phased resonances between 480 to 530 Hz. The actual frequency response (FRF) to the applied force is shown in Figure 14, indicating that a resonance condition is present in the gear [7].

Figure 14. (a) Real Component of Displacement, Indicating the Amount of Response IN PHASE; (b) Imaginary Component of Displacement, Indicating the Amount of Response OUT OF PHASE; (c) Log. Magnitude of the Forcing Function; (d) Phase Lag of Displacement Behind Force.

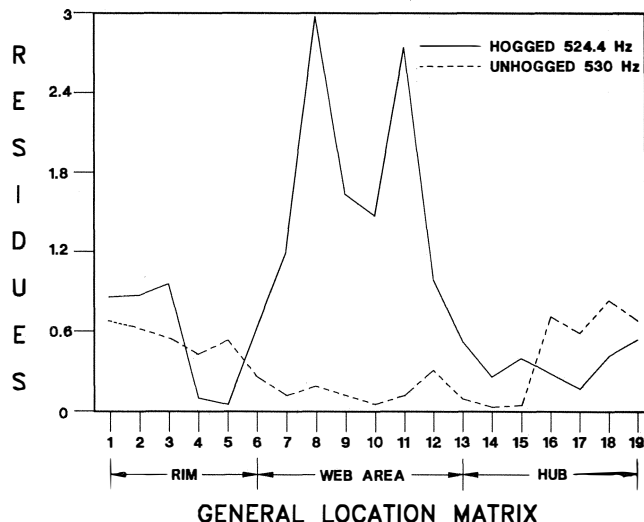
The residues from the damping values at the rim, web area, and hub are graphed in Figure 19 for the partially hogged and unhogged gears, clearly indicating the ability of the unhogged gear to operate more stably in the presence of an excitation force.

Figure 19. Comparison of the Partially Hogged and Unhogged Gear Transfer Function Residues at Their Respective 524 Hz and 530 Hz Excitation Responses. Points 1-6 were measured on the rim, points 7-12 in the web area, and points 13-19 on the hub.

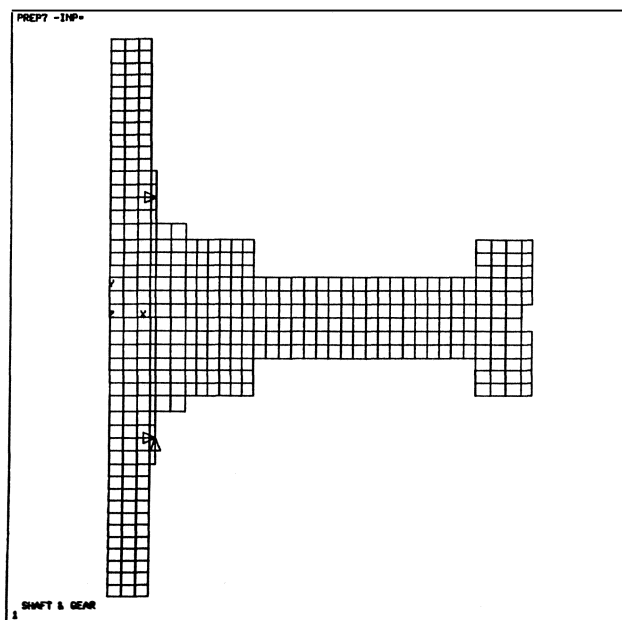
They put their inhouse dynamicist to work on modelling the gear using a finite element analysis program. They found bending modes at 474 Hz and 497 Hz. Damped response analysis was also performed using the bearing stiffness and damping coefficients at operating speed. The first bending mode frequency occurred at 525 Hz, precisely what was measured in the field. Their work is shown in Figure 20 [9].

Figure 20. Finite Element Analysis Performed by the OEM.

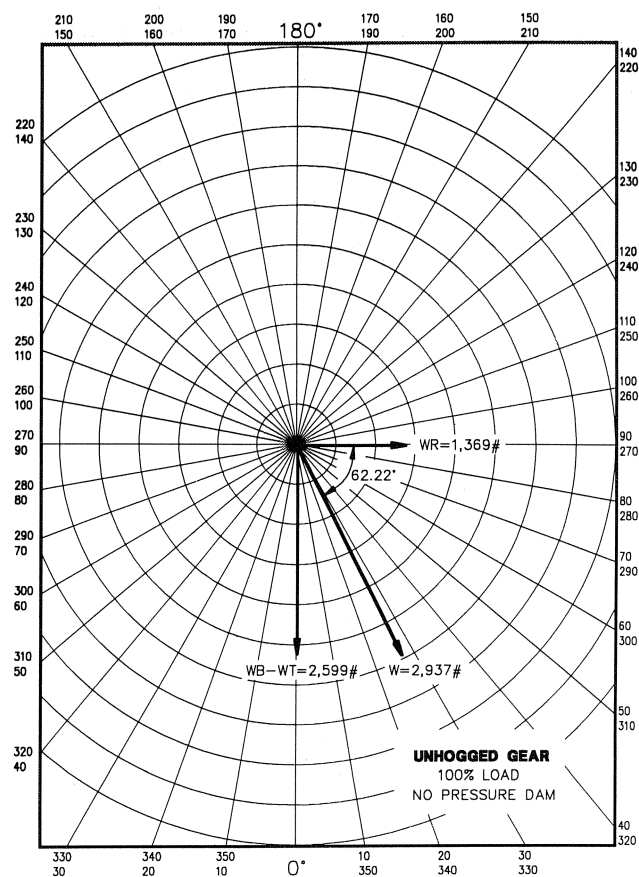
During the data review, two more benefits were realized by using the heavier, unhogged gear. First, the gear shaft would remain firmly in the lower quadrant of its bearings under all load conditions (Figure 21). Second, the additional mass of the gear changed the stiffness of the shaft, and moved the shaft critical speed out of the operating region.

Figure 21. Bearing Load Vector—Unhogged Gear.
